Acid rock drainage in mountain catchments from the Pyrenees

J. CIRÉS^{*1}, J. PIÑA¹, M. VILA¹ AND C. GARCÍA-SELLÉS¹

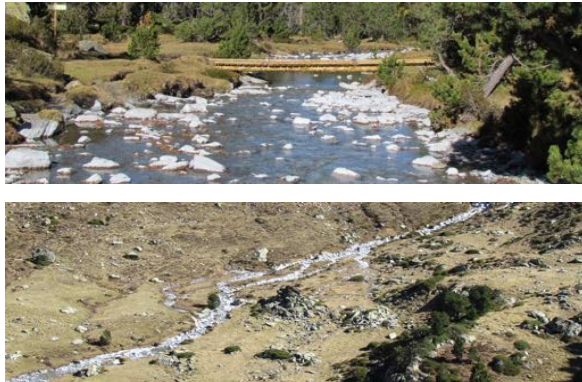
Figure 1: Streambeds with aluminium-rich white coatings.

Since the early 2000s naturally occurring acid rock drainage (ARD) in headwater catchments from the Pyrenees is causing acidification of lake and stream mountain waters. ARD also results in forming extensive aluminium-rich white coatings on the streambeds. The coatings are currently very visible in the landscape (Fig. 1). Before 2000 no white streambed coatings existed in these catchments. ARD is now spreading across the Pyrenees, aluminium white streambed coatings are continuously popping up in the highest catchments of the mountain chain.
