Borosilicate glass dissolution in the presence of cementitious waste forms

YELENA KATSENOVICH¹, VADYM DROZD¹, LEONEL LAGOS¹ AND MATTHEW ASMUSSEN²

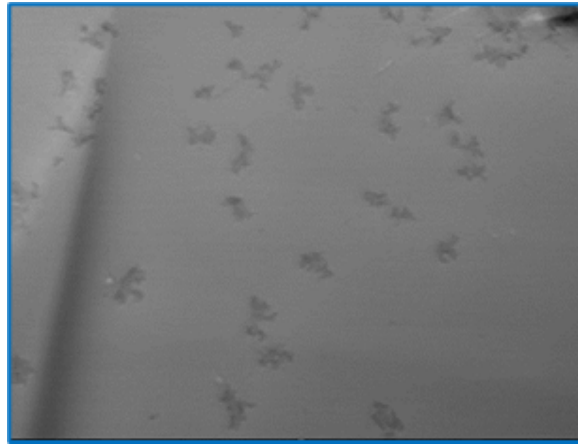
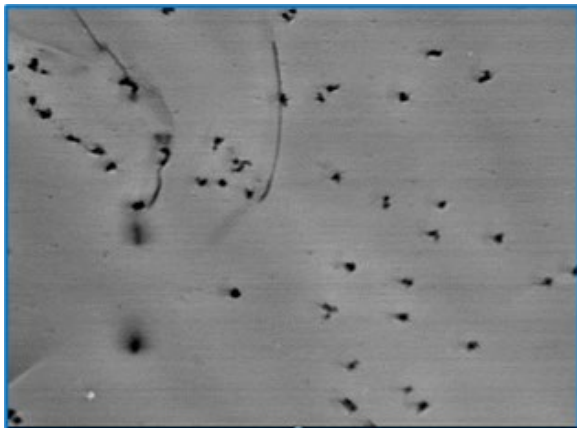
Figure 1. SEM images of the glass particles used in the static corrosion test. Left: deep corrosion pockets on glass treated with pH 12 buffer solution. Right: minor corrosion pits observed on glass surface exposed to GC solution.
