**Mineralogical changes as a result of flooding experiments for Enhanced oil recovery in fractured chalk.**

<sup>1</sup>Institute for Energy Resources, <sup>2</sup>The National IOR Centre of Norway, <sup>3</sup>Institute of Mechanical and Structural Engineering and Materials Science, University of Stavanger, Ullandhaug, 4036 Stavanger, Norway

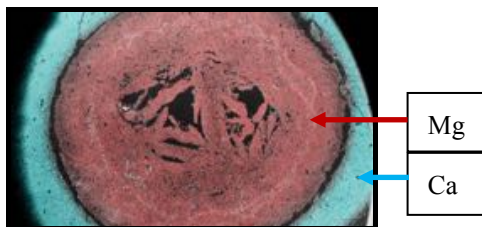
*FEG-SEM image of a fracture (diameter: 2,9 mm) in chalk flooded with MgCl<sub>2</sub> at 130°C, demonstrates spectacular precipitation processes after only 67 days of flooding. Main elements identified by EDS-detector are Mg and Ca in fracture and core respectively.*
