# Tracing downriver mining contaminants using Sm-Nd and Sr isotope signatures: the case of the iron-rich tailings from the failed Fundão dam at Mariana along the Doce River, southeast Brazil

CLAUDIO M VALERIANO, CARLA C NETO, GILBERTO S VAZ, JANIS S NUNES AND MONICA HEILBRON

Rio de Janeiro State University

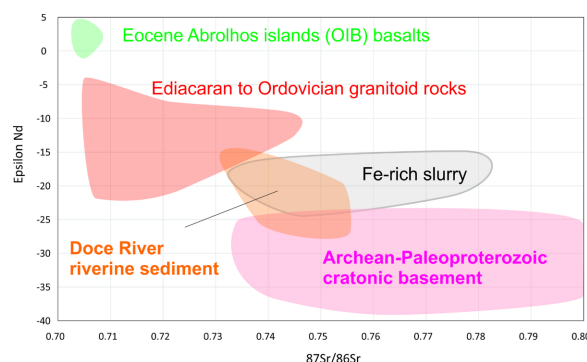
This work presents new TIMS Sm–Nd and Sr isotope data on the fine-grained fraction ( $< 74 \mu\text{m}$ ) of iron-rich fluvial sediment related to the November 5th, 2015 Mariana accident, caused by the failure of the Fundão dam, an iron tailings pond operated by SAMARCO Mining, a Vale and BHP joint venture. The rupture of the Fundão dam caused the sudden release and gravitational flow of approximately 62  $\text{Mm}^3$  of quartz and iron oxide-rich slurry composed of water, fine sand and silt that flowed into the Gualaxo do Norte and Carmo rivers, and eventually along the whole Doce River, reaching the shoreline in 15 days. The event is considered the most serious environmental disaster, having caused 17 casualties and environmental impacts that persist still today. River bank sandy sediment samples were collected from 17 localities distributed from 5 to 500 km downriver from the failed dam, including pre- and post-failure river bank sediment. The latter sediment is clearly distinguishable from the former for the distinct brownish color and finer (fine sand + silt) grain size. Two-component modelling of  $^{143}\text{Nd}/^{144}\text{Nd}$  and  $^{87}\text{Sr}/^{86}\text{Sr}$  isotope ratios of the Doce River sediments show varying degrees of mixtures of three end member components: a) the juvenile Neoproterozoic magmatic arc granitoid rocks of the Araçuaí orogen, including the syn- and post-orogenic granitoid remelting products; b) the Archean-Paleoproterozoic São Francisco craton TTG associations and c) the iron-rich slurry, the tailing from the mined and processed primary Paleoproterozoic banded iron formation, which was massively released into the fluvial system (Valeriano et al., 2019). Increasingly juveniles signatures were observed downriver, influenced by the progressive incorporation of magmatic-arc derived debris from the bedrock. These isotope signatures are currently used to monitor the apportion of Rio Doce contaminated sediment into adjacent marin environment.
